# Frozen Waterline Investigation Report

**GGE 15-1032**

*Prepared for:*  
The Niagara Falls Water Board

September 2, 2015

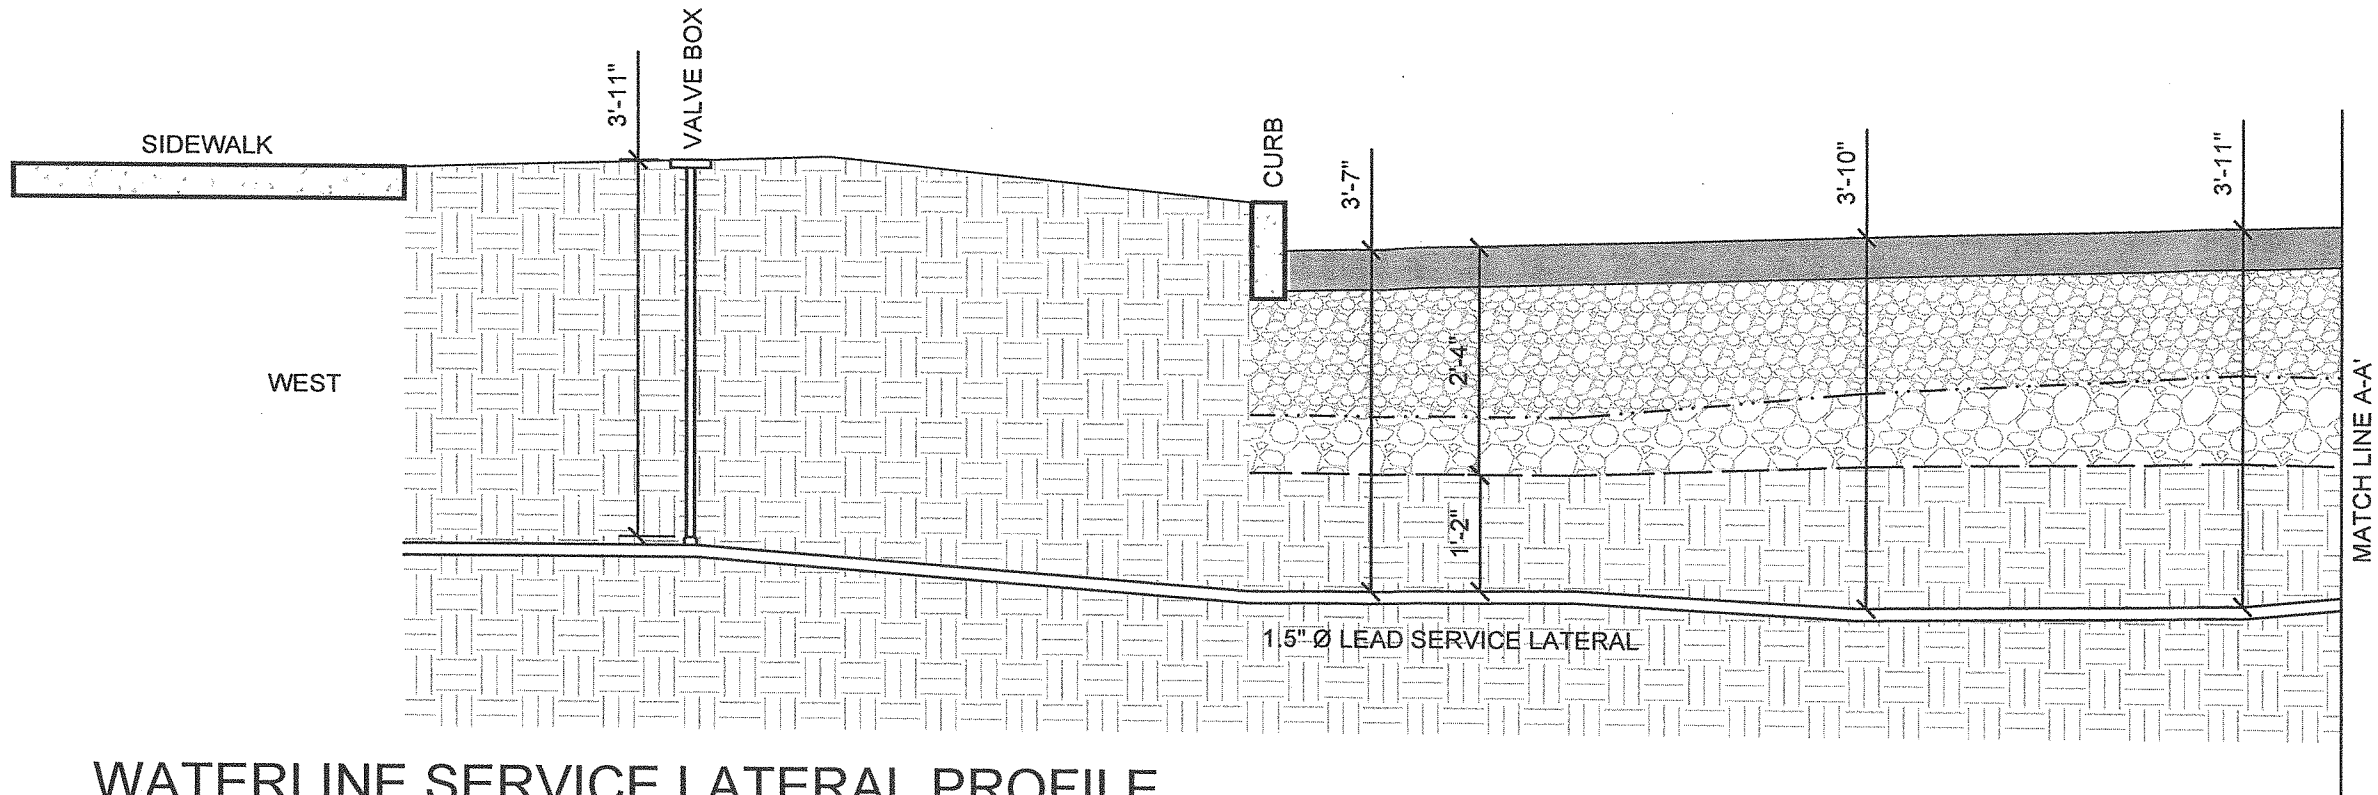
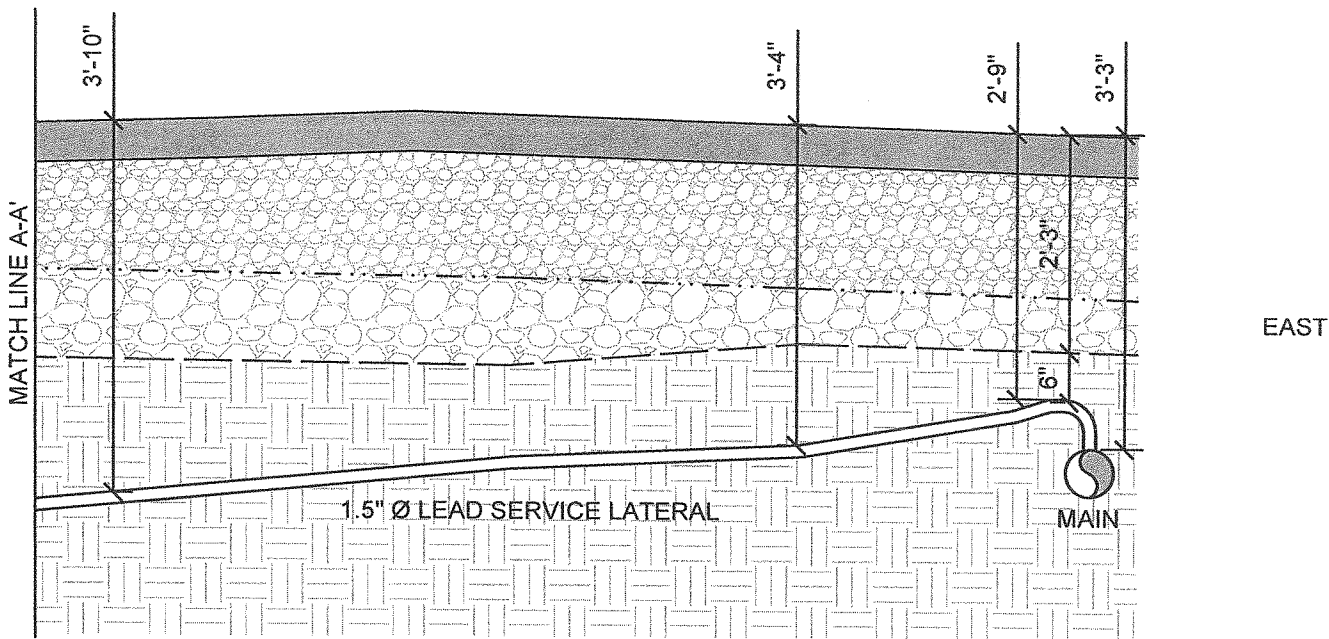
602 72ND STREET PROFILE

The water main on 72<sup>nd</sup> Street, at the two investigated sites, was measured at 3' – 3" below the surface of the pavement. At these locations the street surface was lowered less than 1 inch at house 511 and approximately 6 inches at house 602. At house 511 the service lateral was measured at 2' – 5" below the street at the connection to the water main, whereas at house 602 the service lateral was found 2' – 9" below the street at the connection to the water main (Refer to profile drawings P1 and P2). Our investigation results revealed at house 511 there was only 1 inch of clay soil over the service lateral at the water main connection and at house 602 there was only 6 inches of clay soil over the service lateral at the water main connection.

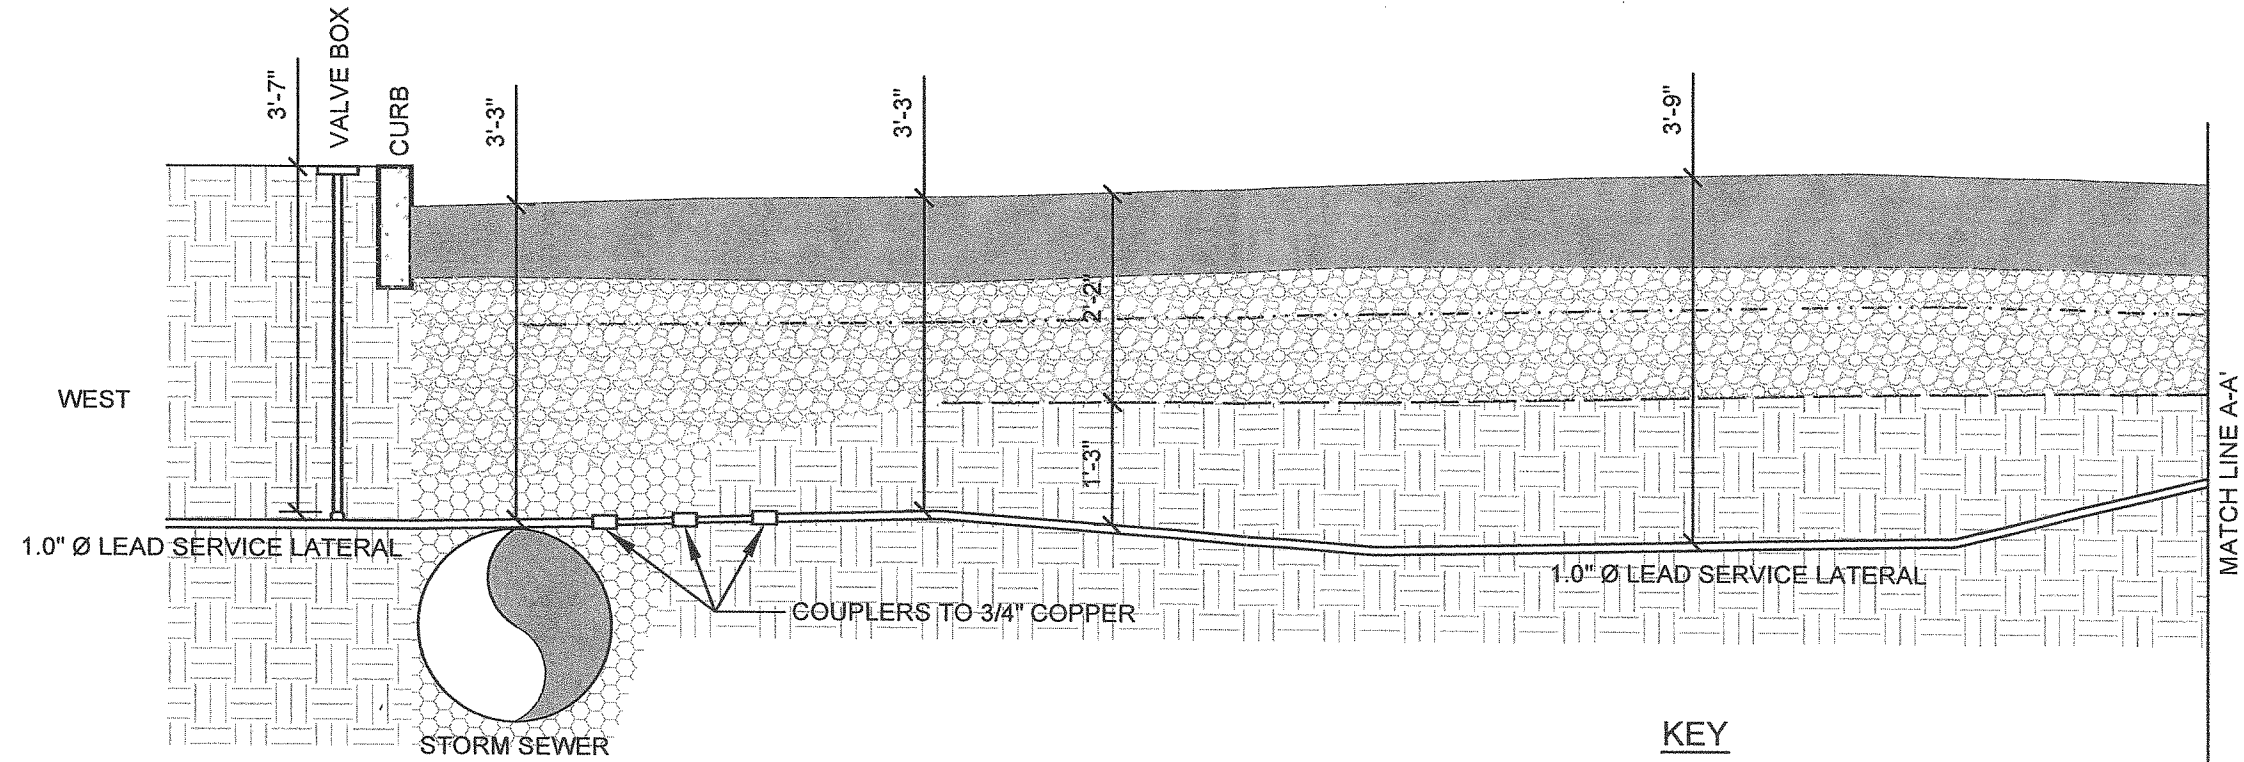
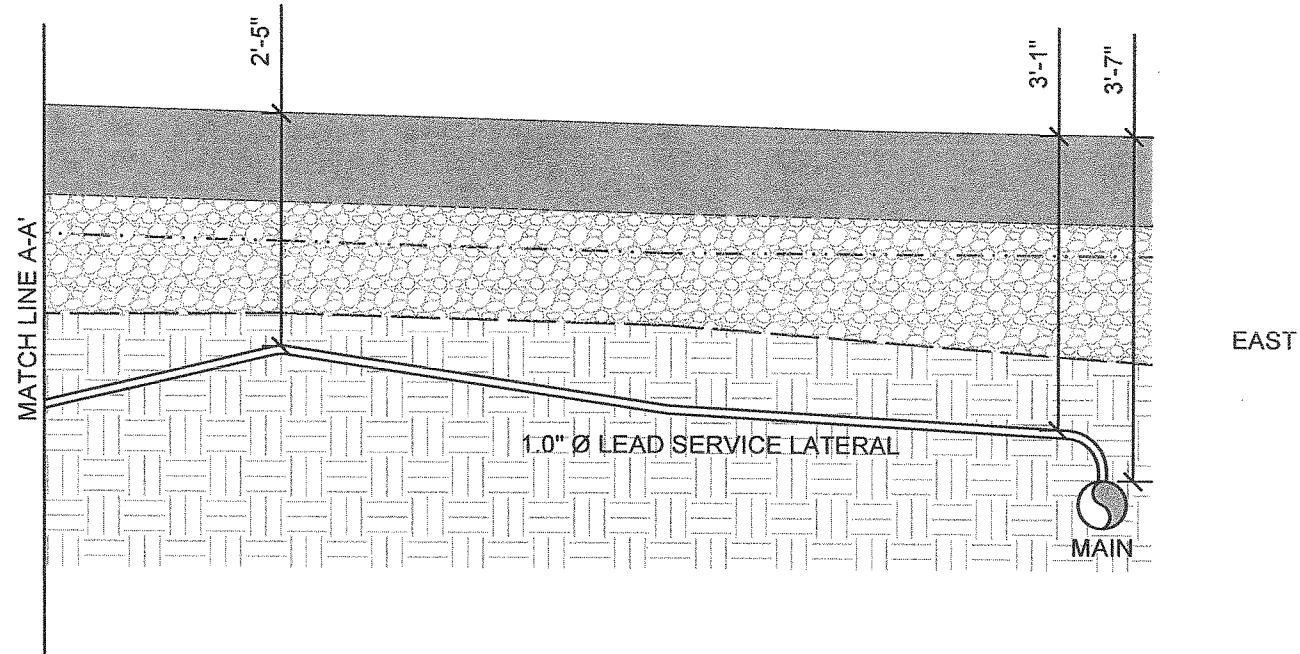
CLIENT: <b>NIAGARA FALLS WATER BOARD</b> PROJECT: <b>NIAGARA FALLS WATERLINE          INVESTIGATION</b>	TITLE: <b>490 77TH STREET PROFILE</b> DWG : <div style="font-size: 2em; font-weight: bold; display: inline-block;">P3</div>
--	--

The service at 490 77<sup>th</sup> Street was found to rest directly on the top of a storm sewer. The direct exposure to near ambient air temperatures indicates a situation that answers the riddle of why this service freezes.

5. The location of the service lateral over the storm sewer provides for exposure to ambient air temperatures and increased freezing potential. The service lateral should always be installed beneath the storm sewer piping.

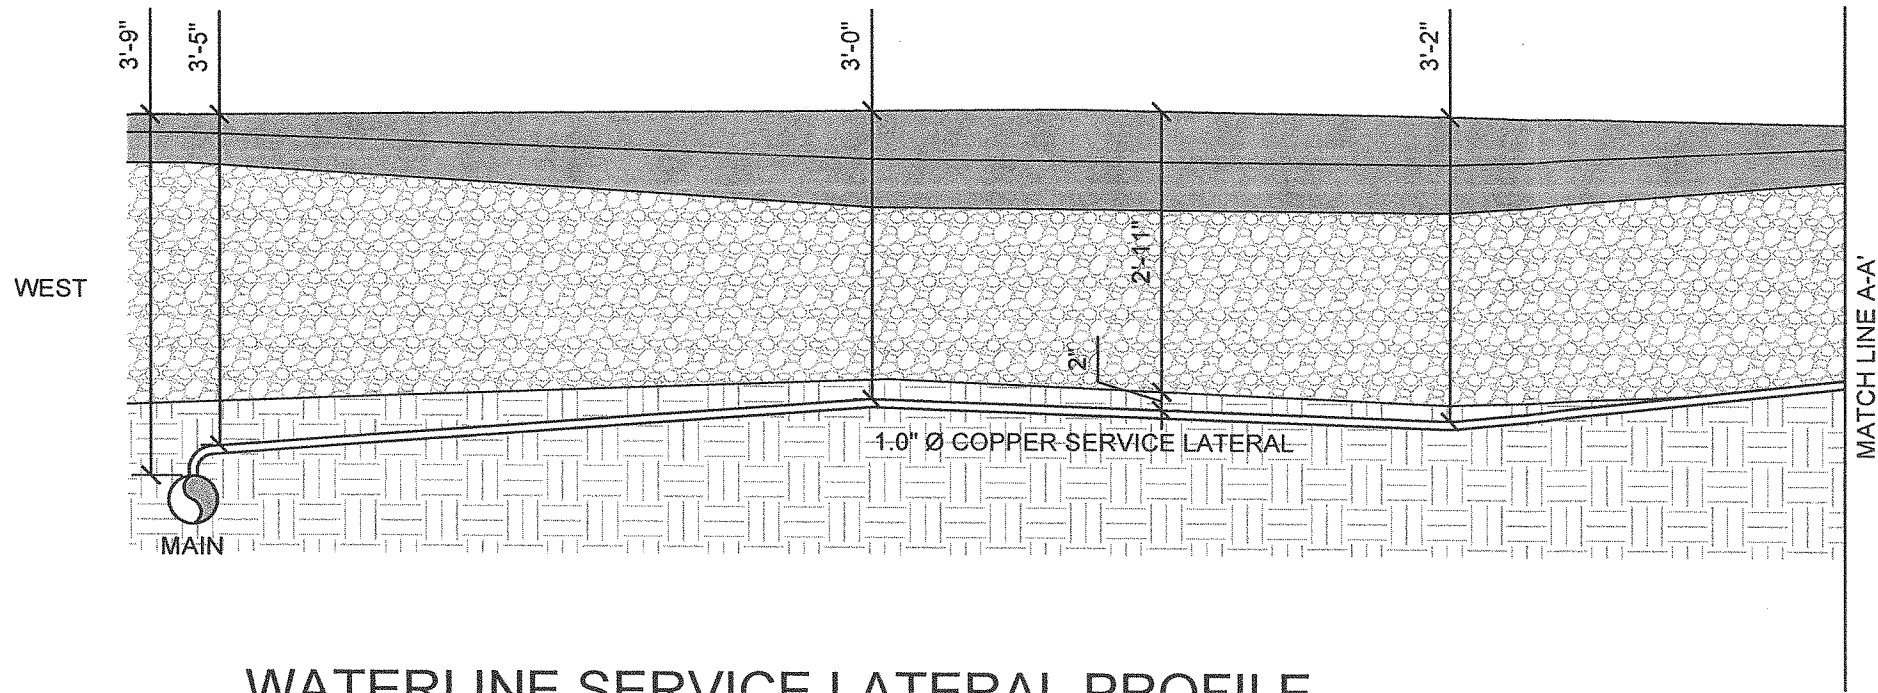
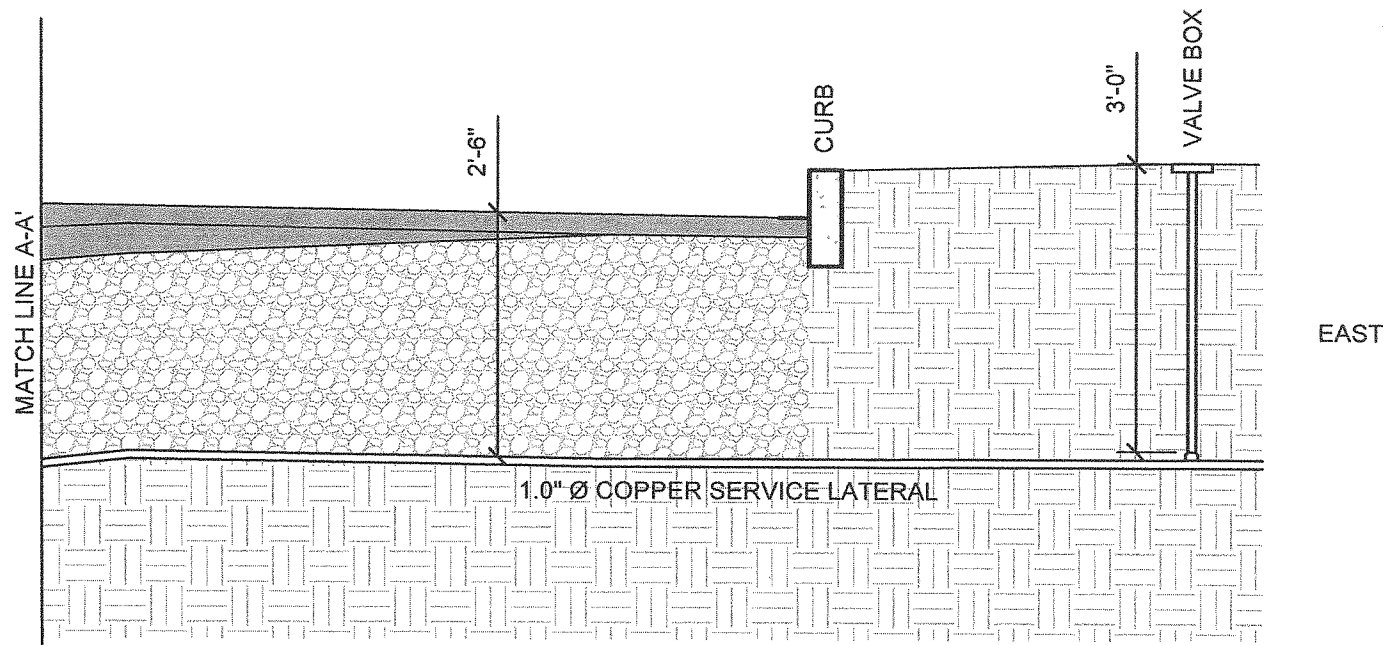
TITLE:  
619 26TH STREET PROFILE

<b>P3</b>	<b>6).</b> 490 77 <sup>th</sup> Street	Included on drip program, likely frozen in 2014.	3'-1", decrease to 2'-5", crosses storm sewer.
<b>P4</b>	<b>7).</b> 619 26 <sup>th</sup> Street	Located in a cluster area.	3'-5" Cover at main, 3'-0" cover at valve box, mostly stone backfill.
<b>P9</b>	<b>8).</b> 2929 20 <sup>th</sup> Street	Random selection, new construction.	3'-8" Cover at main, 5'-1" cover at valve box, mostly stone backfill.
<b>P10</b>	<b>9).</b> 571 77 <sup>th</sup> Street	Any house, near cluster, did not freeze in 2015.	3'-0" Cover at main 3'-2" cover at valve box, short side, 8"± clay backfill.
<b>P7</b>	<b>10).</b> 1358 Michigan Avenue	Away from a cluster, did not freeze in 2015.	4'-1" Cover at main, 3'-11" at valve box, mostly clay backfill.

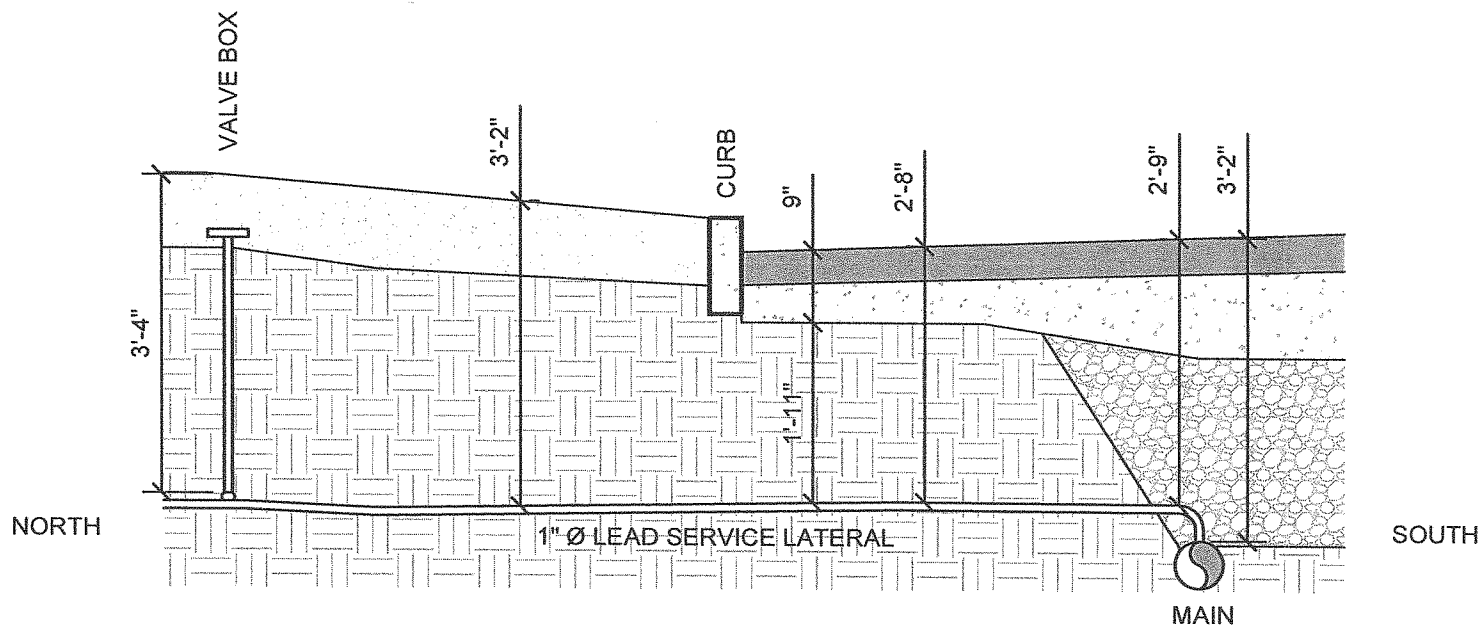
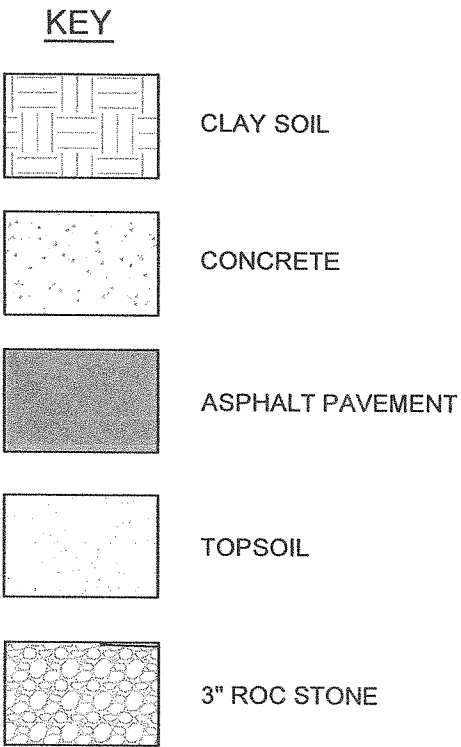
2926 ONTARIO AVENUE PROFILE

PROFILE	LOCATION	SELECTION CRITERIA	COMMENTS
<b>P8</b>	<b>1).</b> 2926 Ontario Avenue	Reported frozen condition early during records, February 16, 2015: Within a cluster area.	2'-9" Cover at main, main buried in stone.
<b>P5</b>	<b>2).</b> 1906 Welch Avenue	One of last locations to report frozen condition, March 1, 2015.	2'-9" Cover at main, lots of clay cover.
<b>P2</b>	<b>3).</b> 511 72 <sup>nd</sup> Street	Shallow valve box depth, located on 72 <sup>nd</sup> Street.	2'-5" Cover at main, less than 1" change in street elevation, mostly stone backfill.
<b>P1</b>	<b>4).</b> 602 72 <sup>nd</sup> Street	Deepest valve box depth, located on 72 <sup>nd</sup> Street.	2'-9" Cover at main, approx 6" change in street elevation, mostly stone backfill.
<b>P6</b>	<b>5).</b> 1224 13 <sup>th</sup> Street	Included on drip program, likely frozen in 2014.	3'-2" Cover at main, lots of clay cover, not below frost depth.

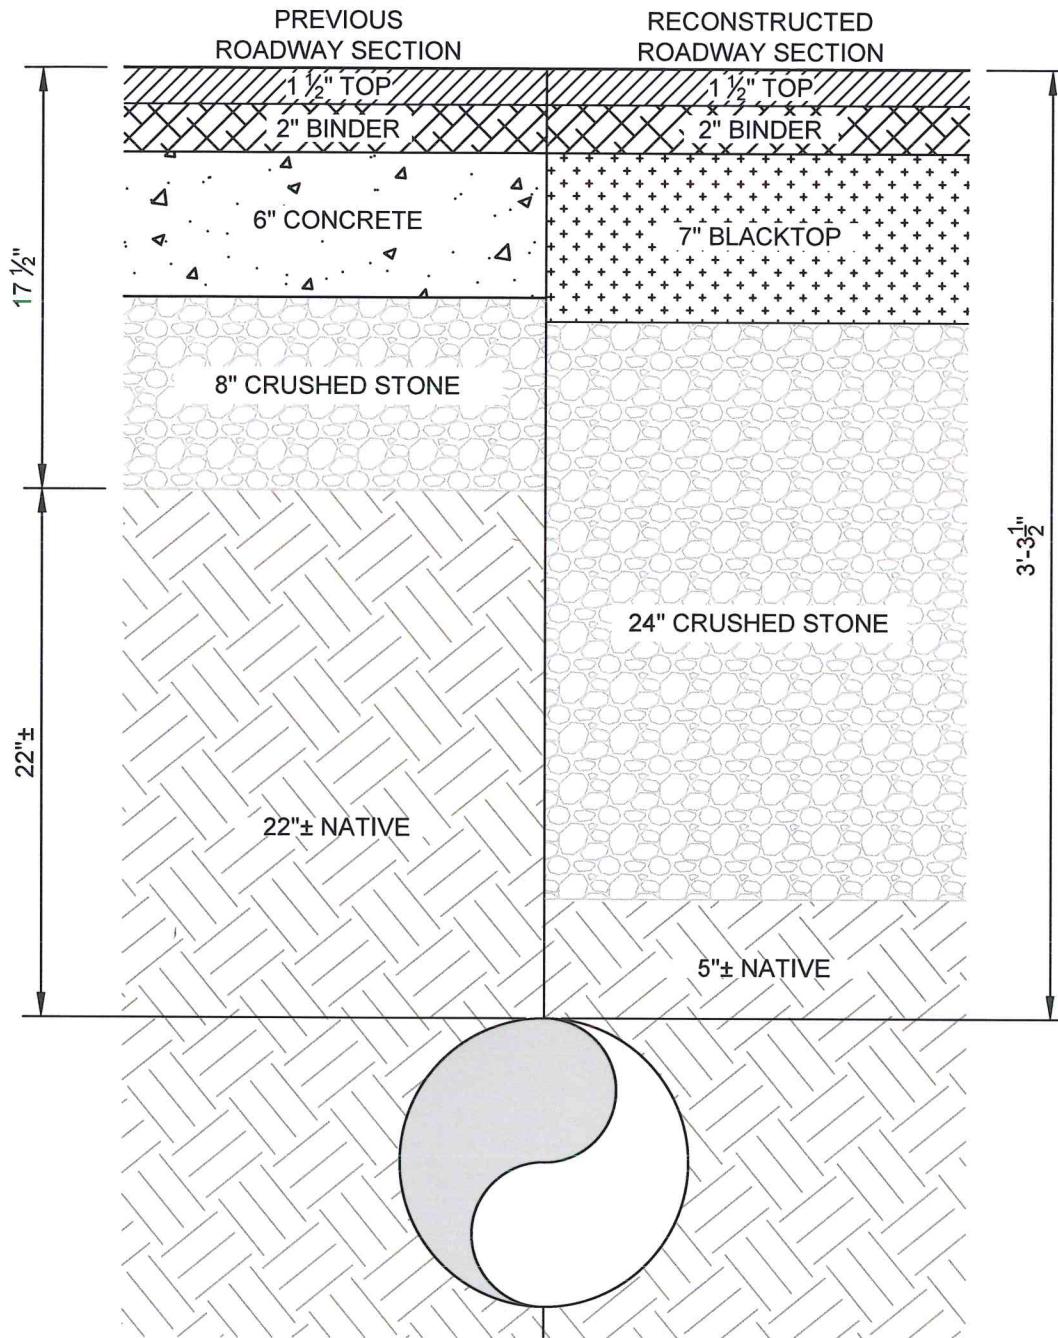
## 72nd STREET RECONSTRUCTION CROSS SECTIONS

Reconstruction of 72<sup>nd</sup> Street resulted in the replacement of approximately 17" of clay with crushed stone (refer to Exhibit 1 in Appendix B). Removal of the clay, which is an excellent insulating material, and replacement with crushed stone, which is a poor insulating material, resulted a 30 % loss of insulating value in the backfill over the main and lateral piping (refer to calculations in Appendix C). Although there were four homes along 72<sup>nd</sup> Street where the road was lowered by 6 inches, and hence the cover over the waterline decreased by this amount, there were seven homes that reported frozen waterlines where the street level was lowered by only 1 inch or less (refer to Table 2.0 in Appendix D). It is apparent therefore, that replacement of the clay soil with crushed stone was the principal factor causing the 25 residences on 72<sup>nd</sup> Street to experience frozen water services, not the lowering of the street grade.

2. The service lateral was backfilled with crushed stone, which exhibits poor insulating properties, as opposed to clay soil, which exhibits good insulating properties. This is very evident along 72<sup>nd</sup> Street where clay soils were removed during road reconstruction and replaced with crushed stone, therefore increasing the frost penetration potential.

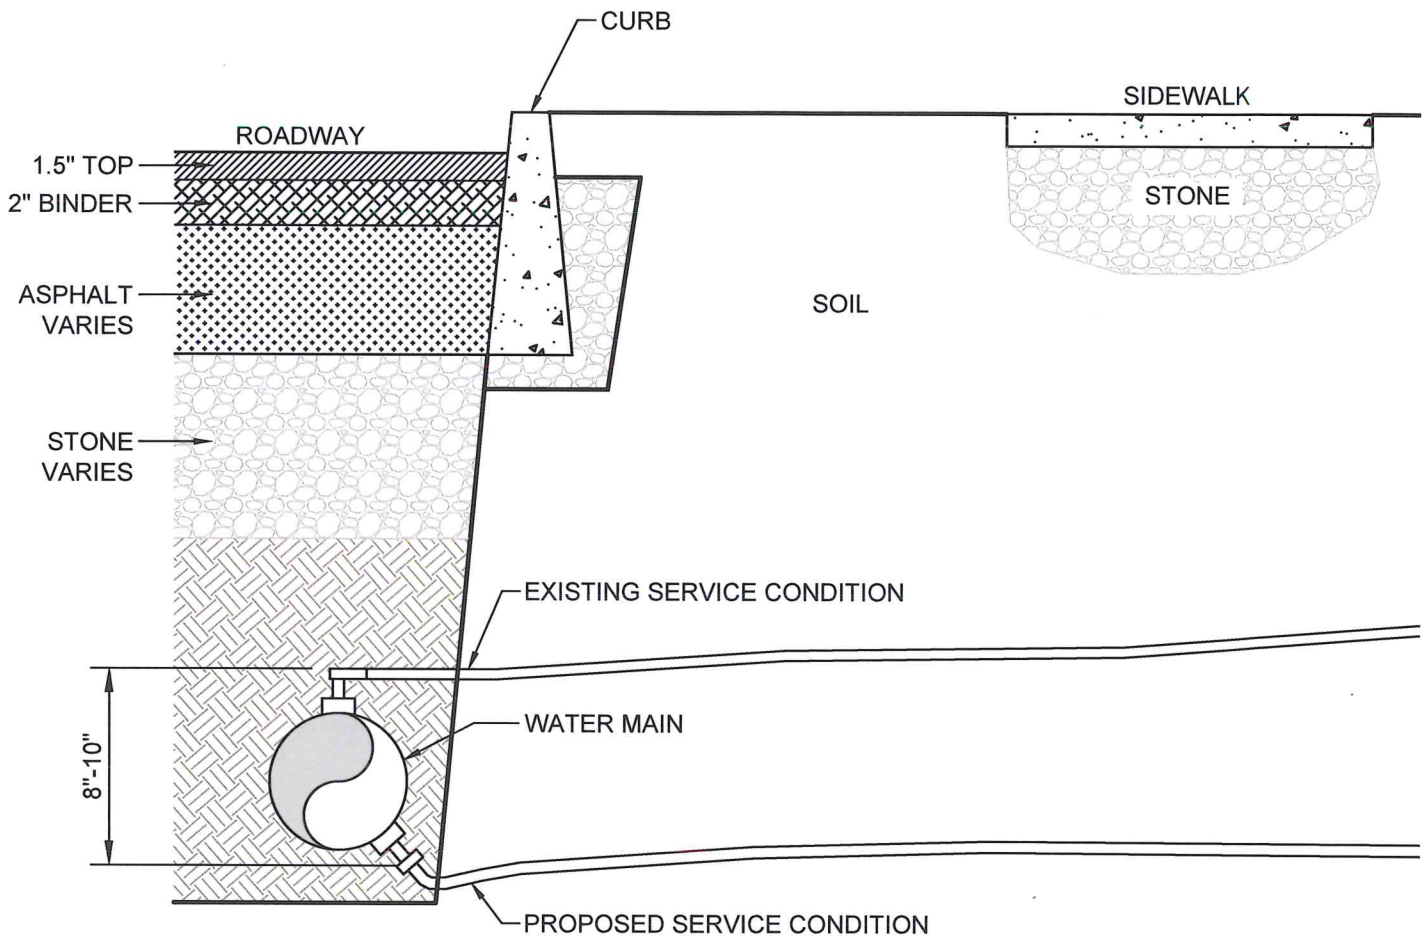
## WATER SERVICE TAP RELOCATION

3. The current location of the service lateral tap at the top of the water main results in a rise in elevation of the service lateral, providing greater freezing potential. When the opportunity arises the tap for the service lateral should be relocated to the side or bottom of the main at problem locations.

- 1.) Make sure the residential valve boxes are fully open.
- 2.) Promote an alternate street reconstruction design that does not diminish the insulation of the piping. Alternatively, lower water mains during street reconstruction if clay backfill is removed or lessened significantly.
- 3.) When work is performed on a service lateral relocate the service connection from the top of the water main to the bottom quadrant, thereby increasing the depth of cover over the service lateral by several inches. (See detail in appendix 5.0)
