APPENDIX C
COLLECTION SYSTEM REHABILITATION RECOMMENDATIONS

MH-1 SUBAREA A
REHABILITATION RECOMMENDATIONS

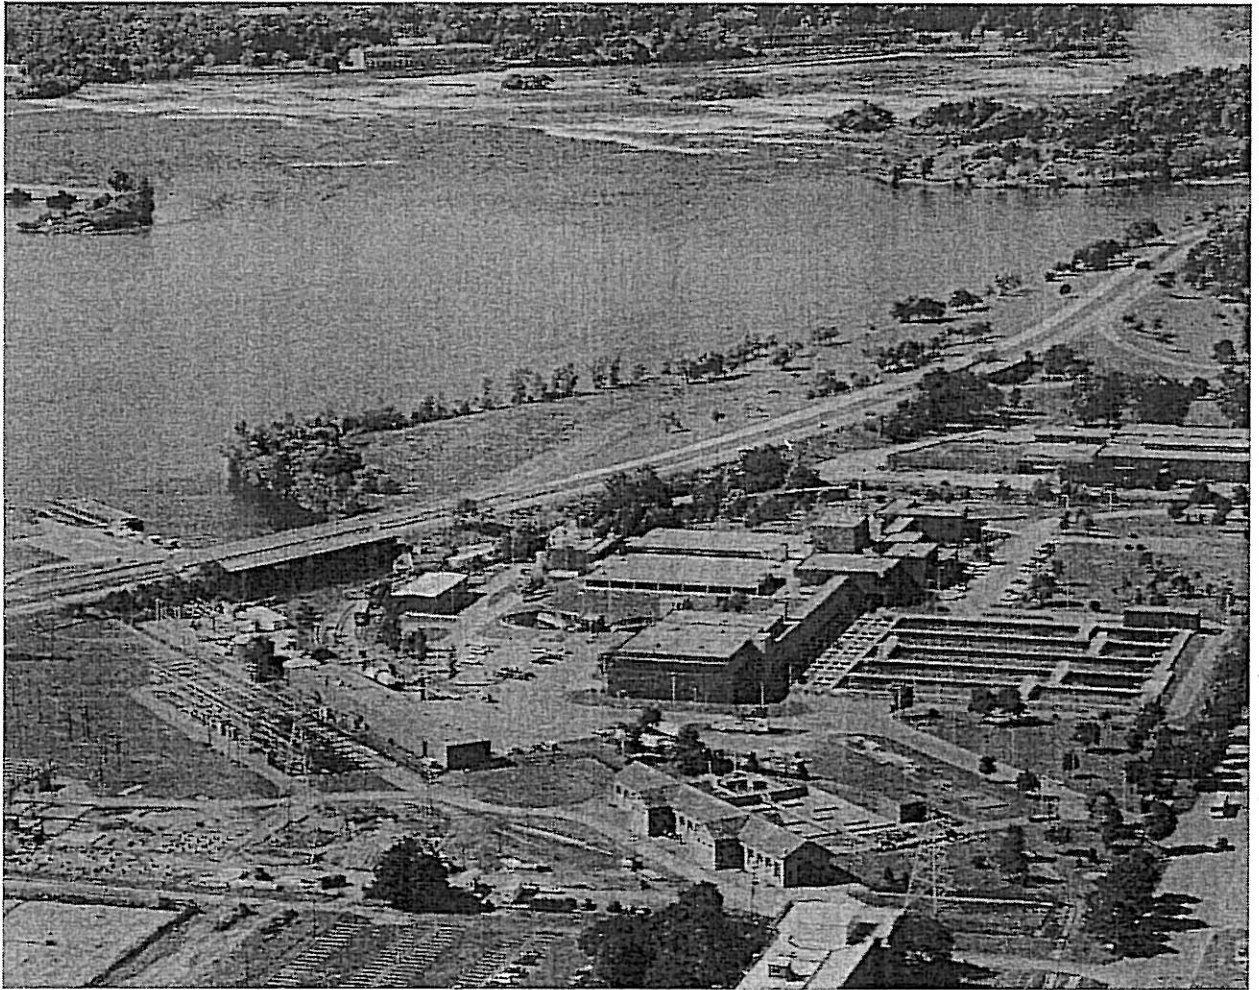
Photo 1 : Niagara Falls Wastewater Treatment Plant

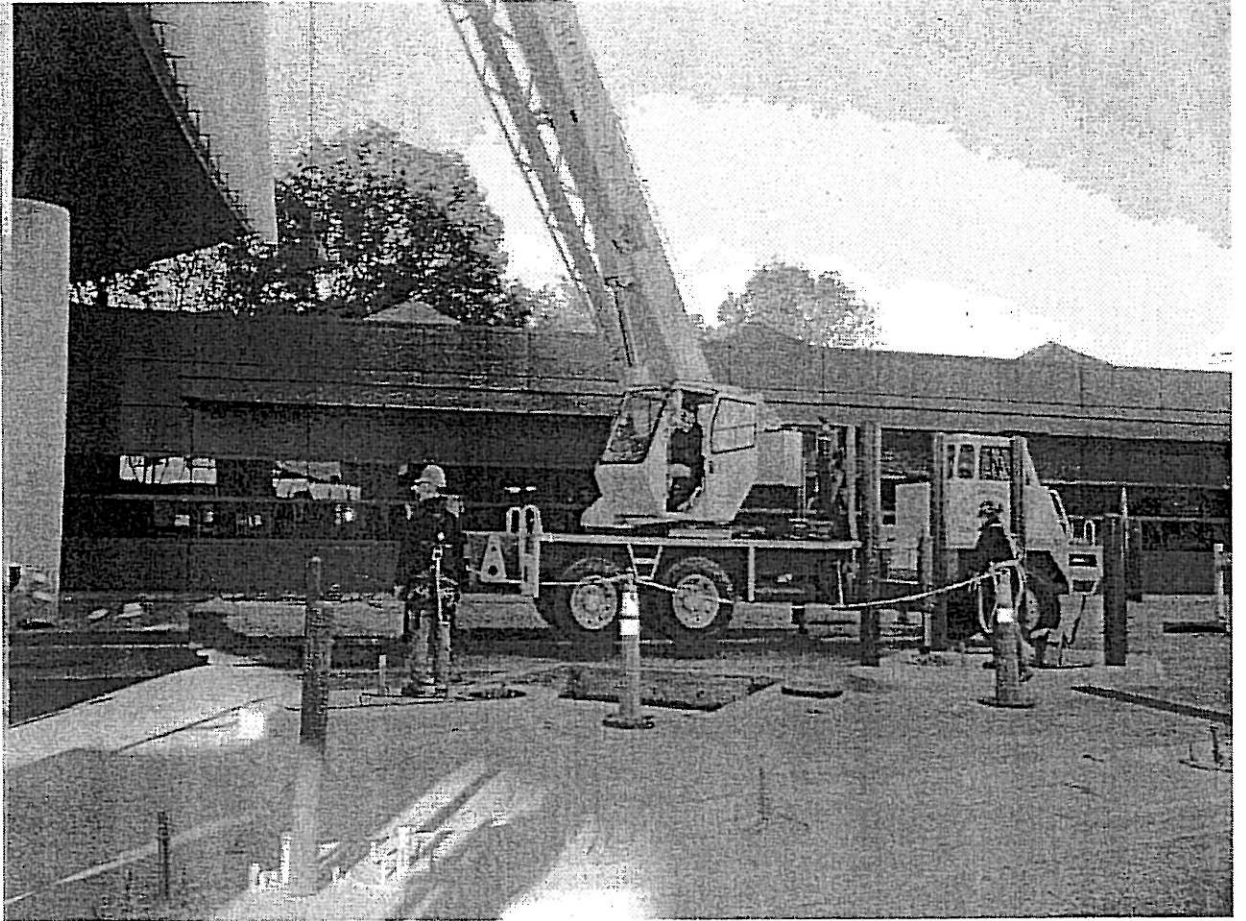
Photo 2 : Removing Falls Street Tunnel Drop Shaft Zero Vault Cover

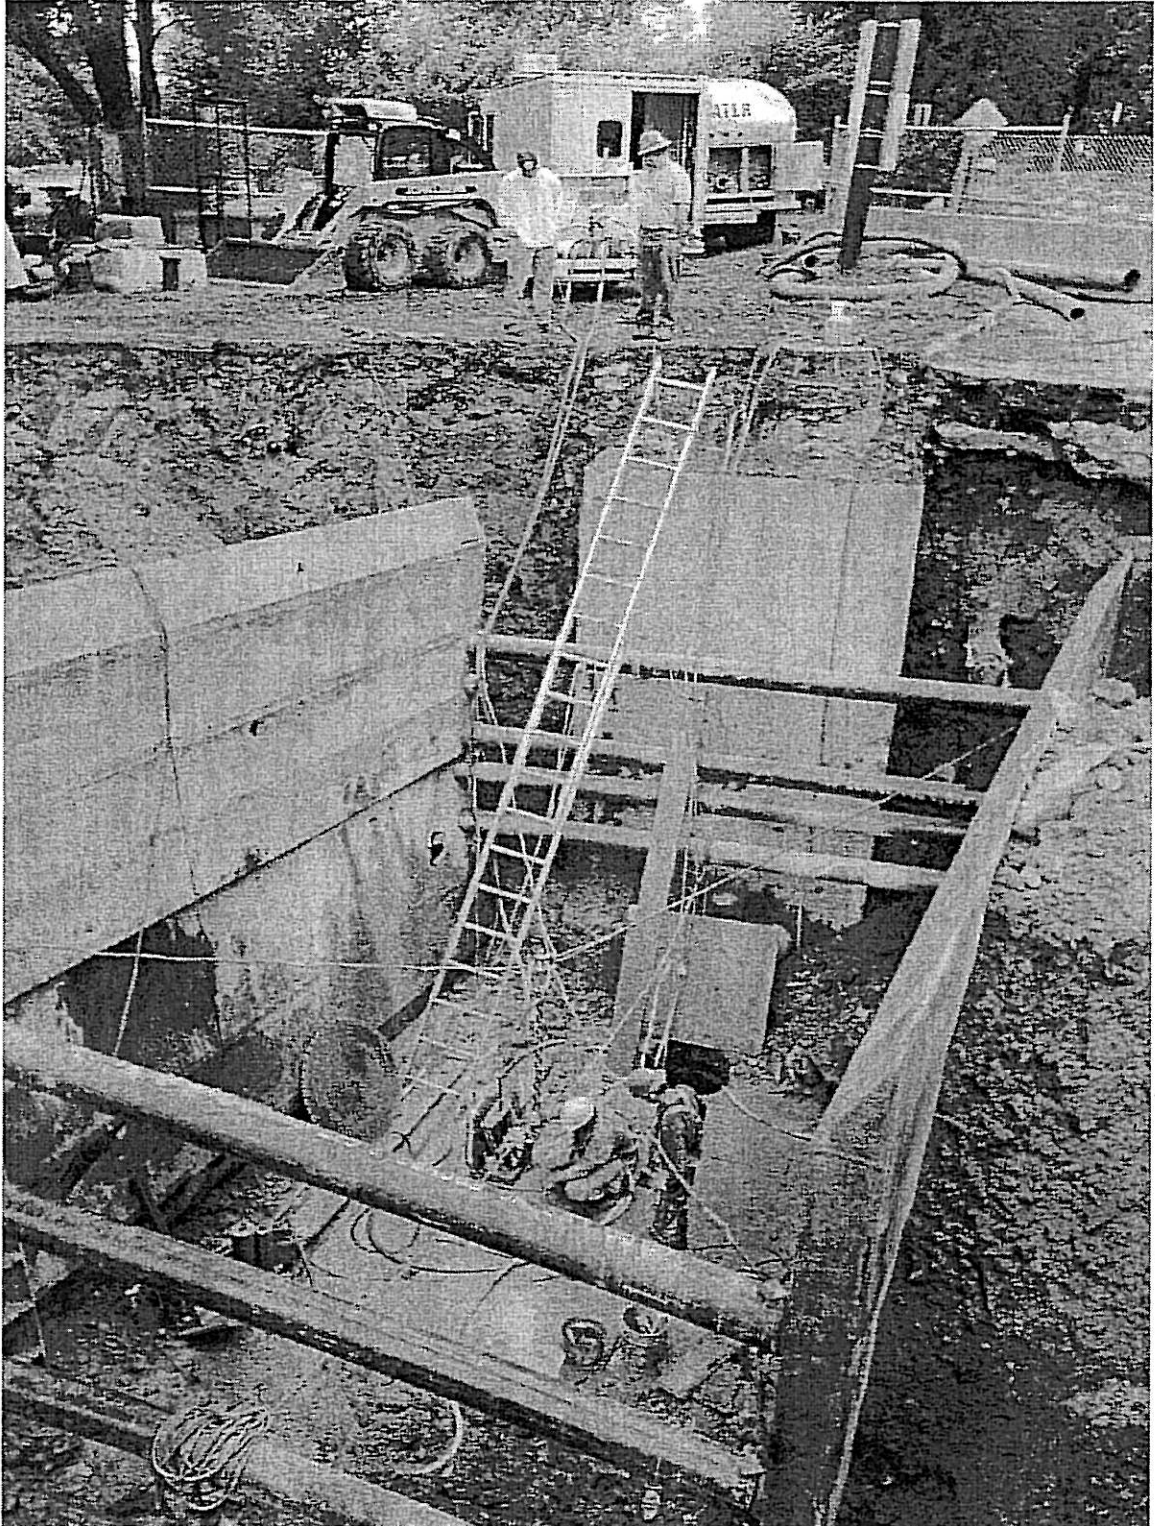
Photo 4 : Contract 52 North Gorge Interceptor Shaft 14 Excavation

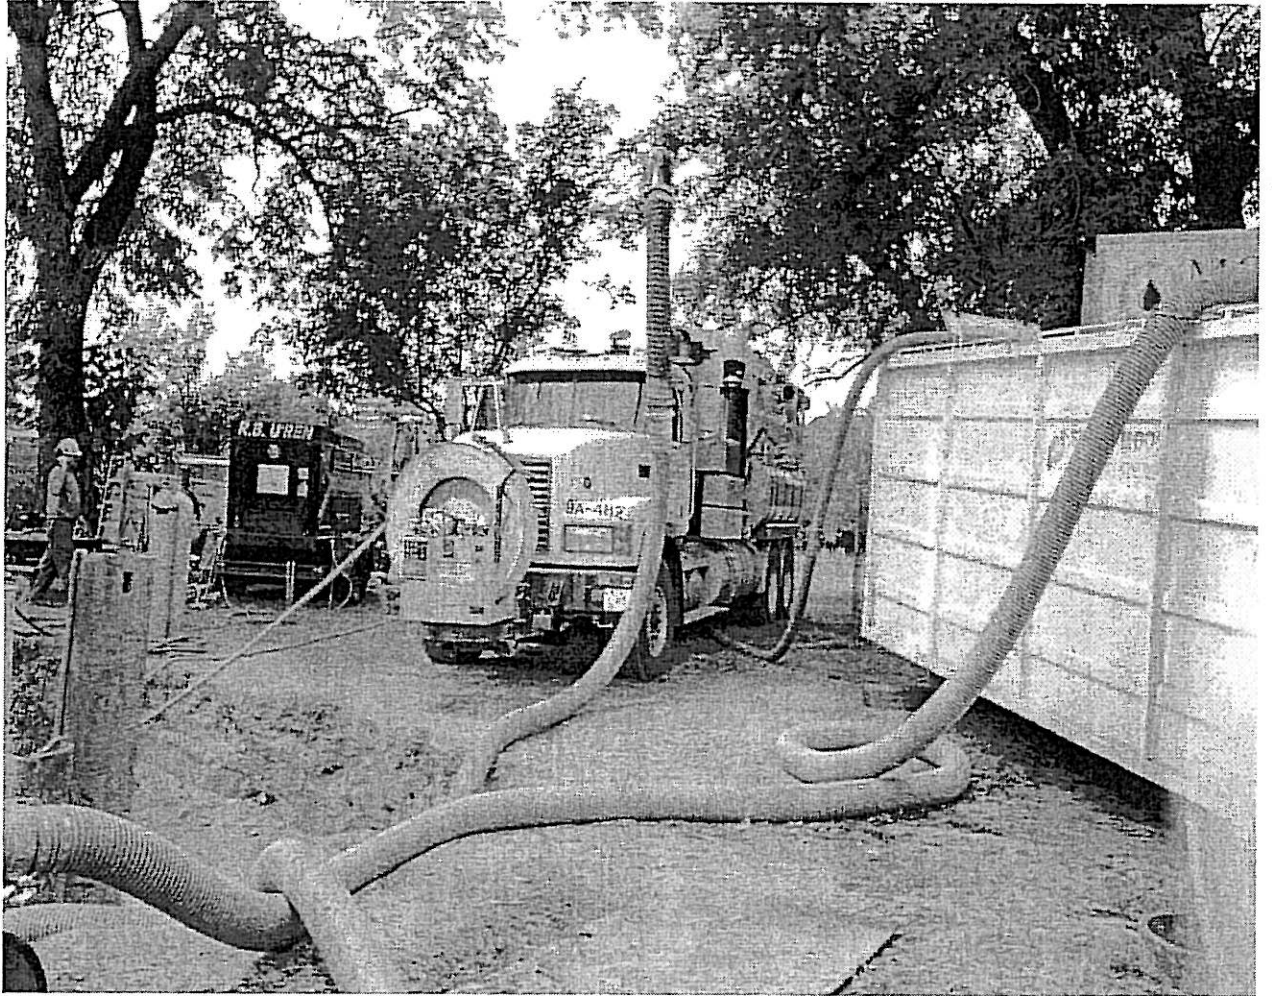
Photo 5 : Contract 52 North Gorge Interceptor Cleaning Equipment

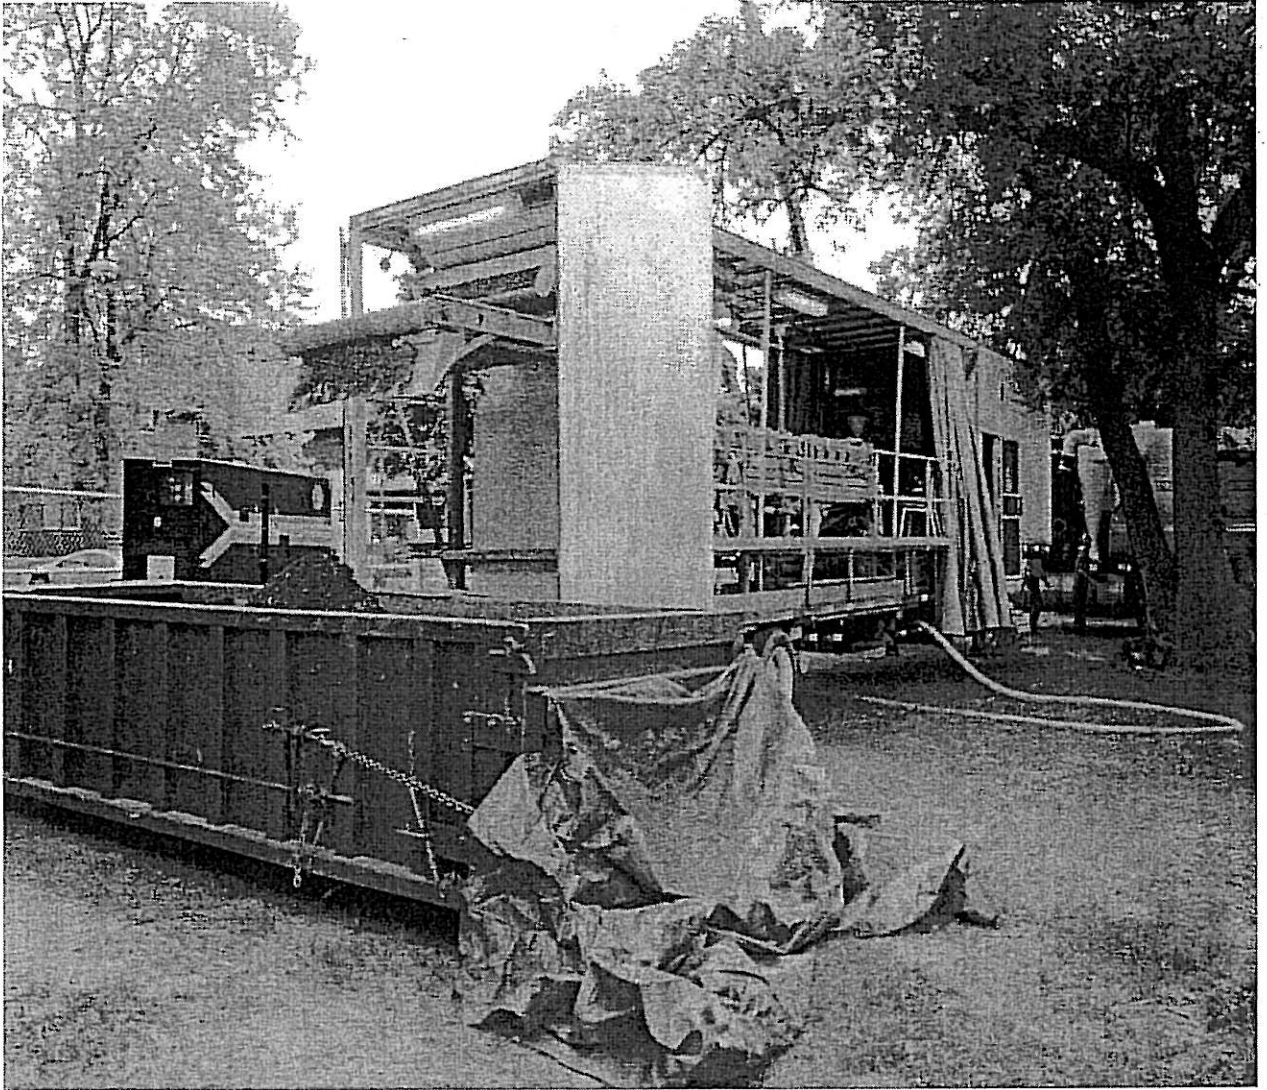
Photo 6 : Contract 52 Belt Filter Press & Debris Roll-Off Container

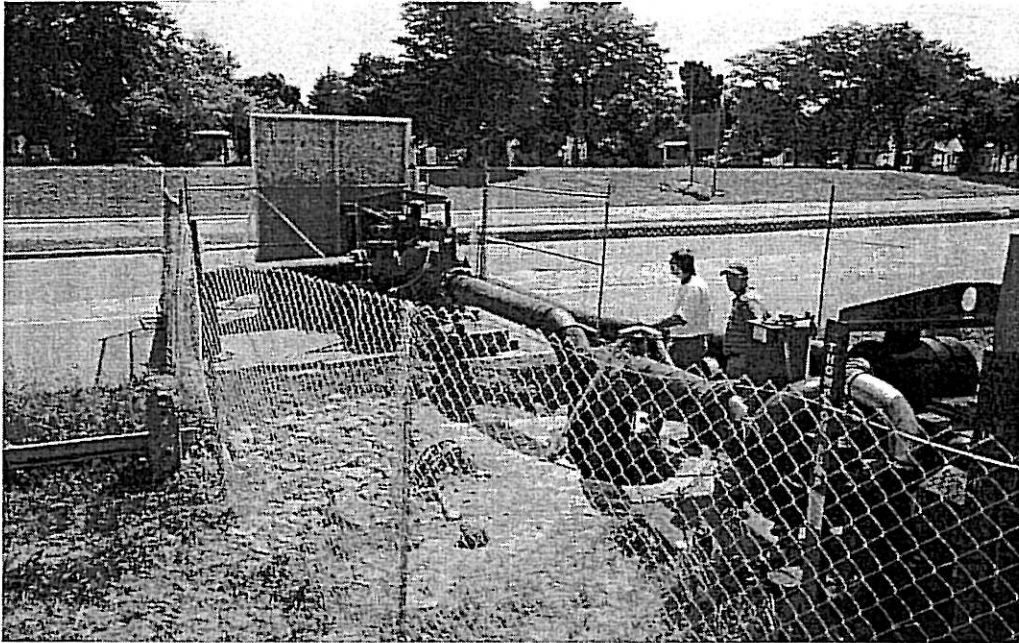
Photo 7 : Contract 52 Bypass Pumps

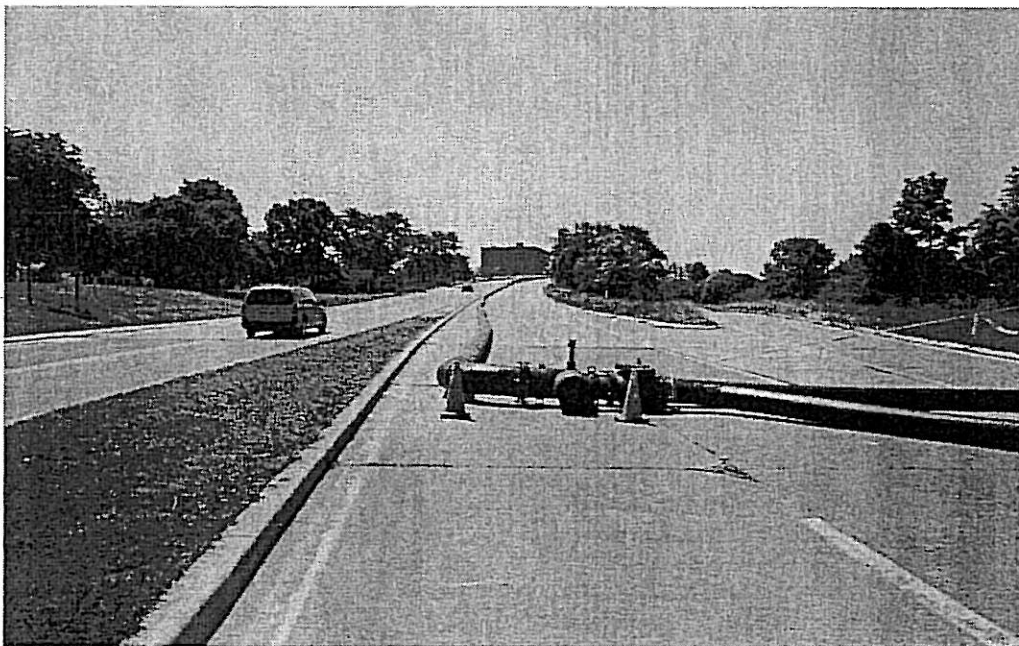
Photo 8 : Contract 52 Bypass Pipeline

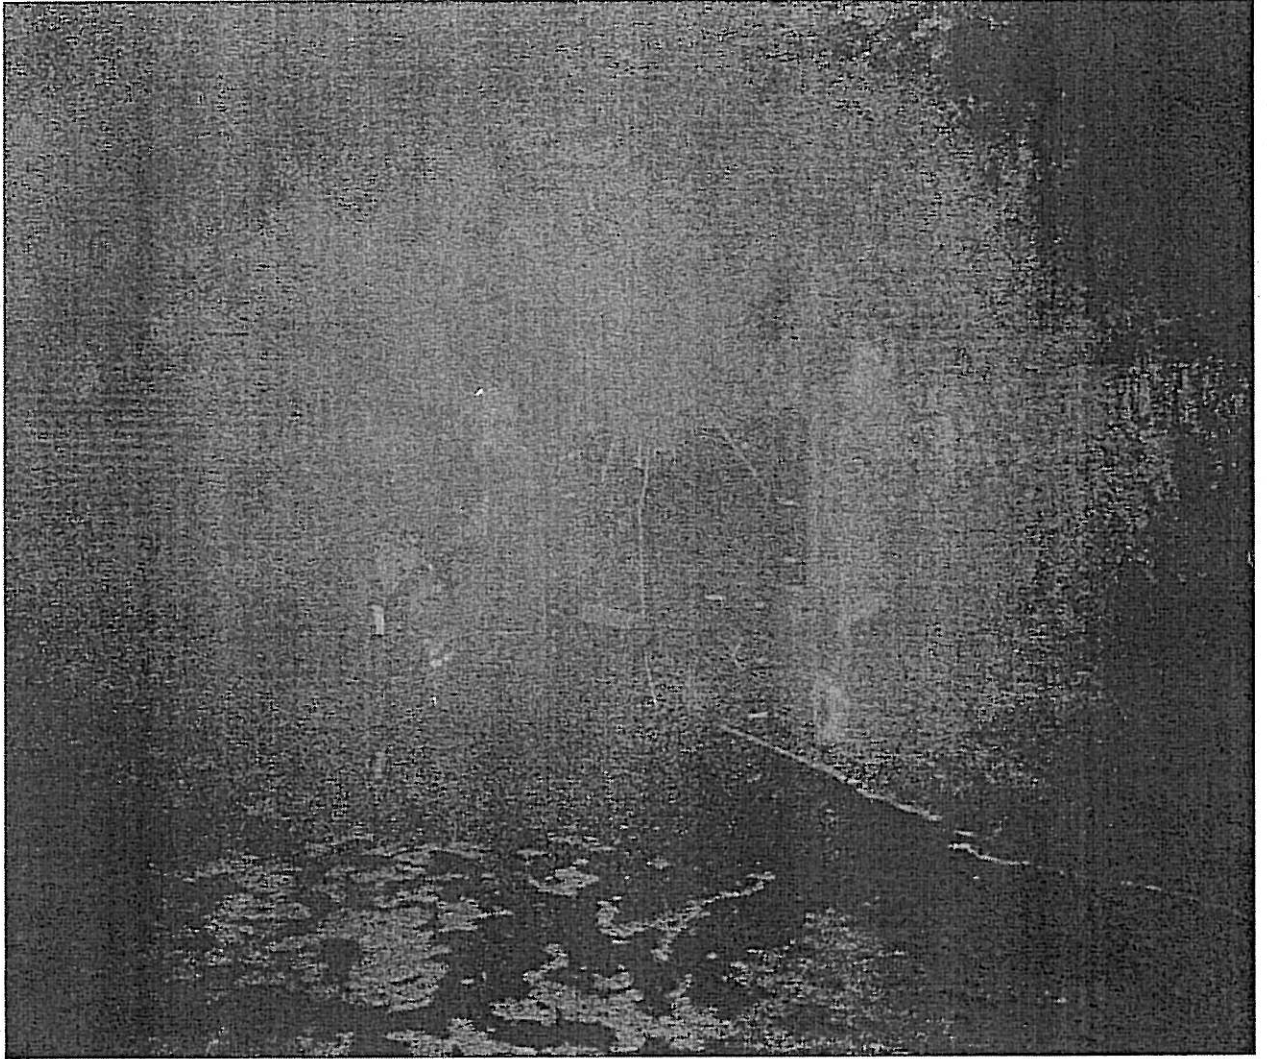
Photo 9 : Contract 52 Garfield Tunnel / North Gorge Interceptor Connection

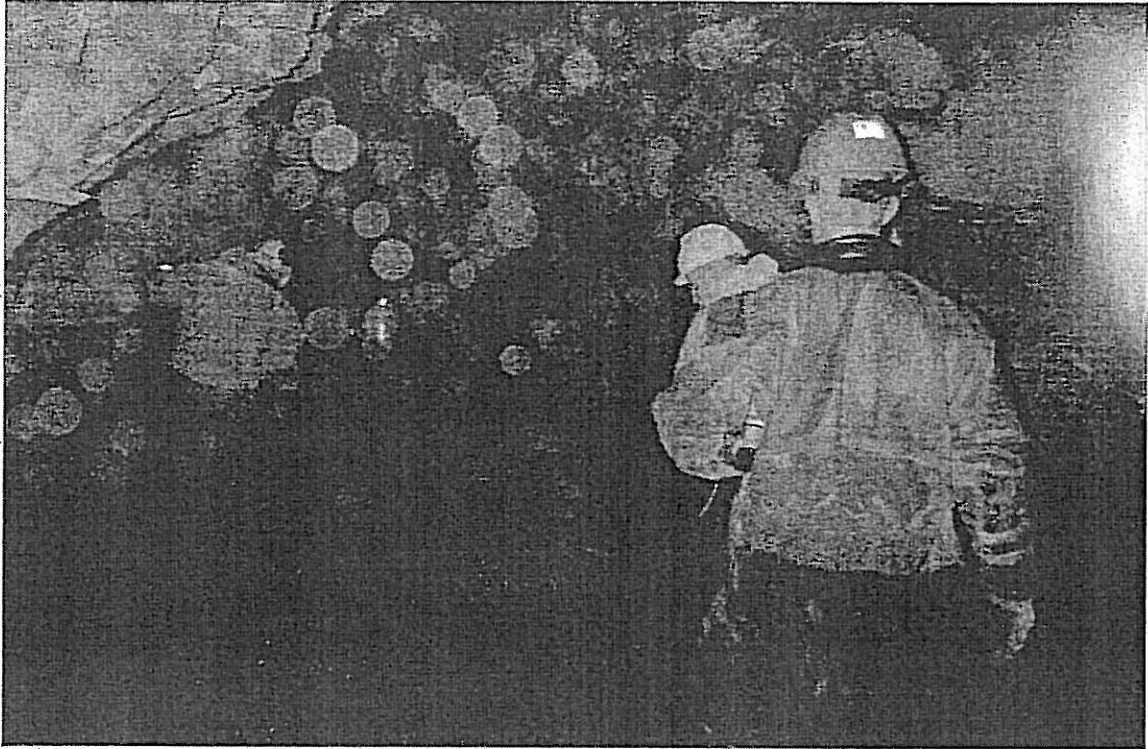
Photo 10 : Inspecting Gorge Pumping Station Approach Tunnel

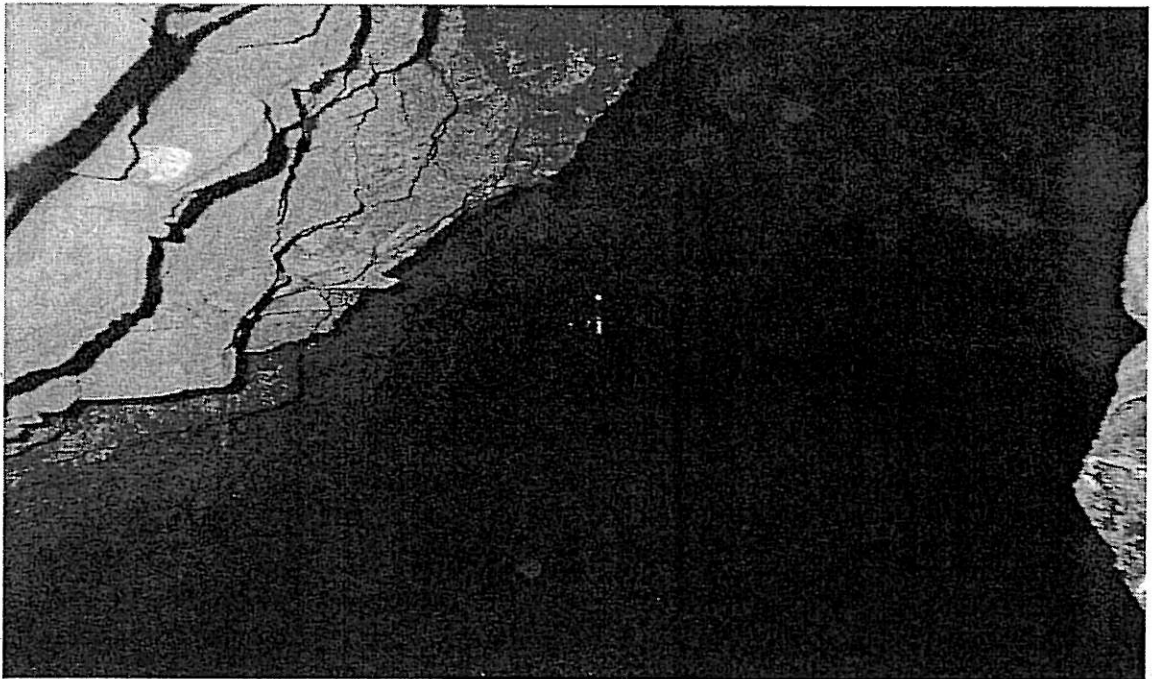
Photo 11 : Inspecting Gorge Pumping Station Approach Tunnel
